The RightShip Safety Insights Series shares key lessons from maritime incidents and RightShip Inspections to highlight identified gaps and provide guidance to help improve onboard practices and reduce risk — supporting our mission of achieving a Zero Harm maritime industry.

This paper focuses on fatalities caused by unsafe practices when using portable lights on board ships and provides insights into risk management and engineering changes that can help prevent these tragic events.

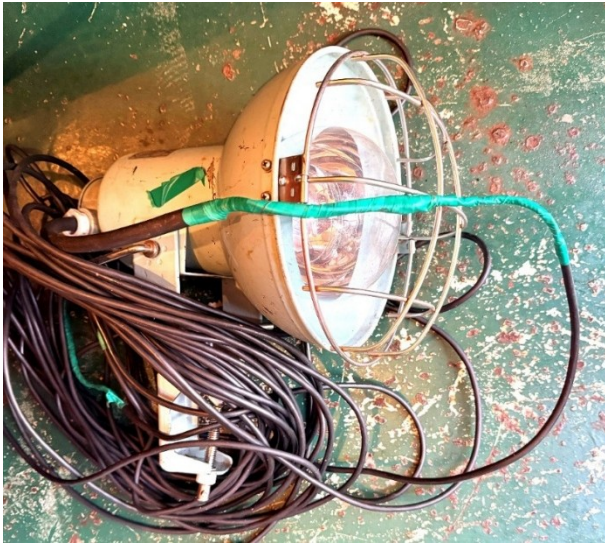
Improper cable connections  
Different specifications of cables connected

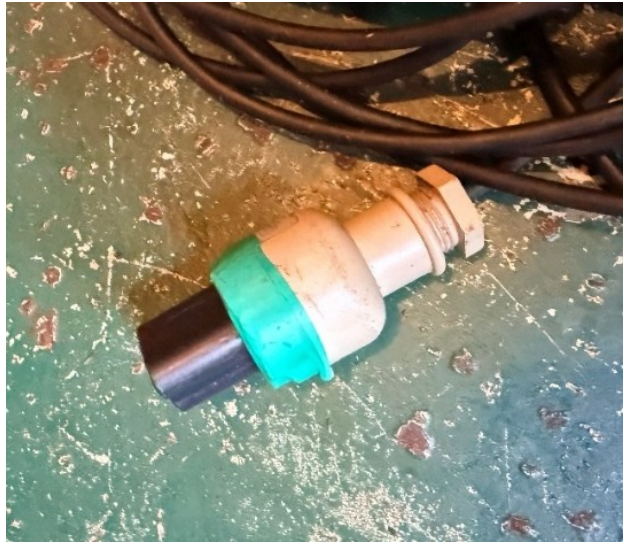
Damaged power plug with unsafe repairs

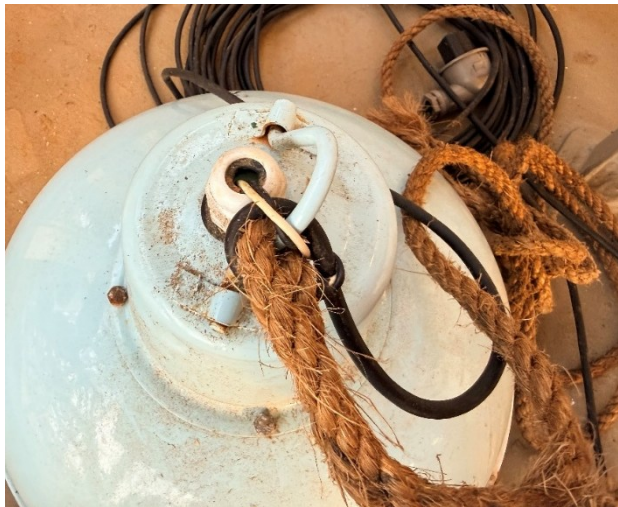
Power cable damaged and missing protective sheath  
Cable gland is loose

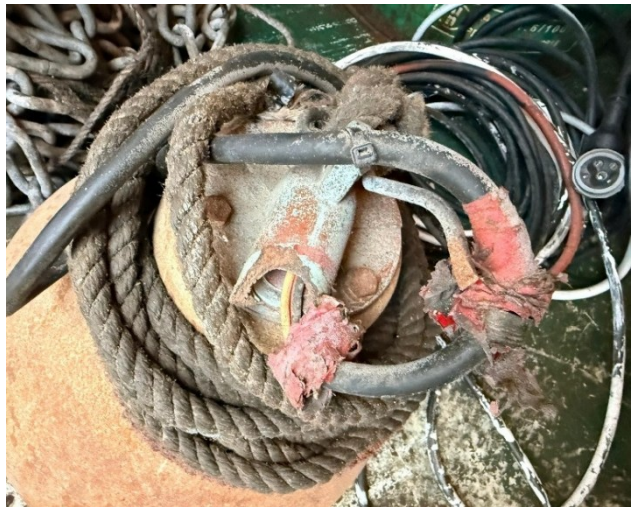
Unauthorised cable repairs and broken power cable gland

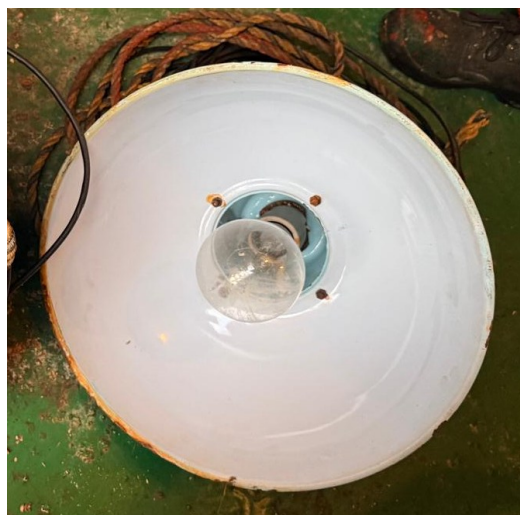
Missing safety guard

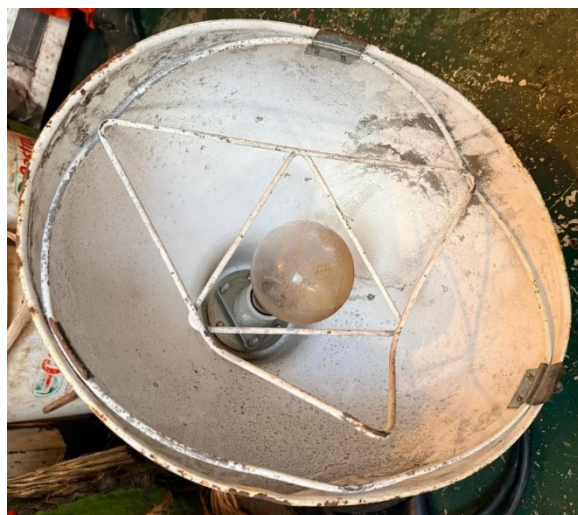
Damaged safety guard
