Hull Structure Supplement

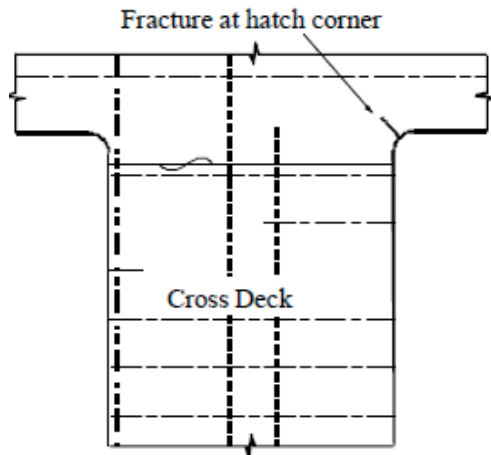
5 Are the main cargo hatch corners free of fractures?

(Bulk Carriers – Guidelines for Surveys, Assessment and Repair of Hull Structures (IACS Rec 76, 2017))

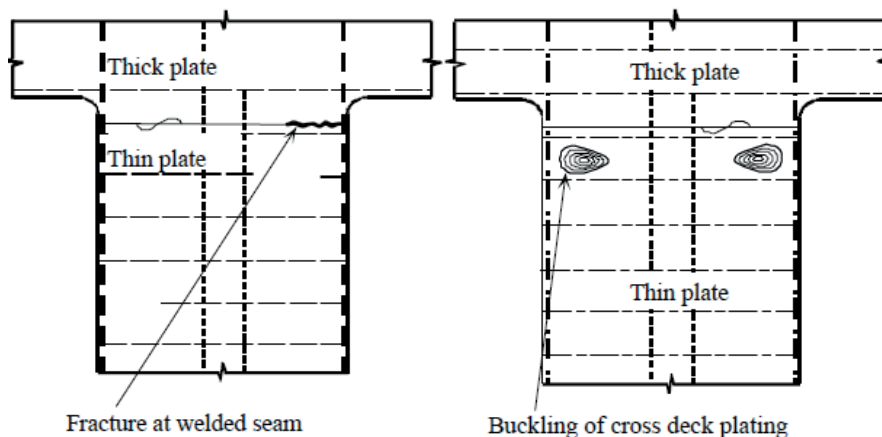
6 Are the cross-deck plates free of any buckling and are the welded seams between thick plates and thin plates at the cross deck free of fractures?

(Bulk Carriers – Guidelines for Surveys, Assessment and Repair of Hull Structures (IACS Rec 76, 2017))

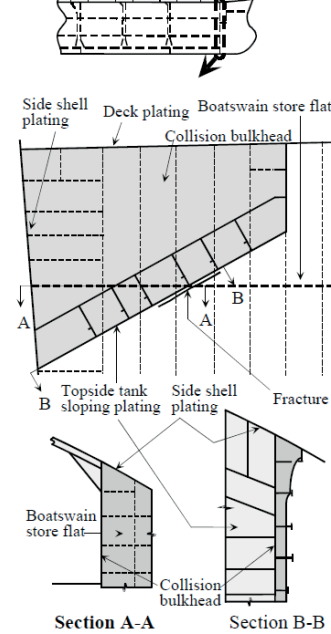
Sketch of damage

17 Are the structures in the way of collision bulkhead at its intersection with the topside tank structure in the foremost cargo hold free of fractures?

(Bulk Carriers – Guidelines for Surveys, Assessment and Repair of Hull Structures (IACS Rec 76, 2017))

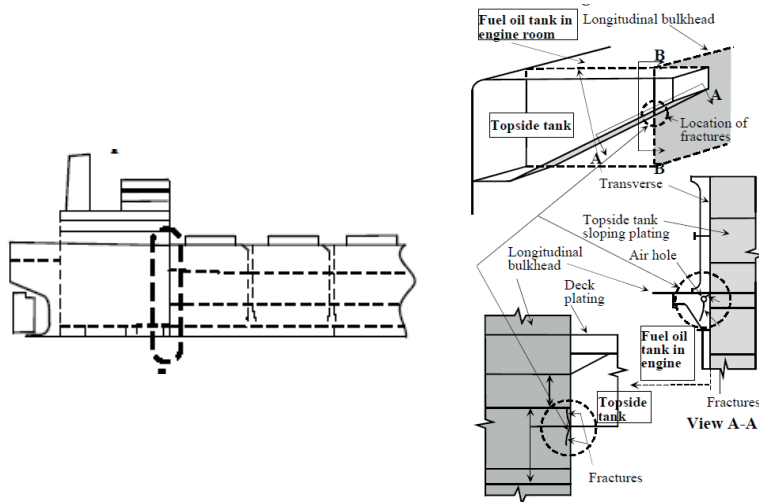
18 Are the structures in the way of the engine room forward bulkhead at its intersection with the topside tank structure in the aftermost cargo hold free of fractures?

(Bulk Carriers – Guidelines for Surveys, Assessment and Repair of Hull Structures (IACS Rec 76, 2017))
